Walk Audit Report

2025 SLO REGION

Nipomo Field Walk – February 21, 2025

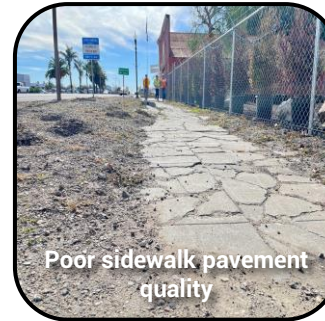
The street sections under review do not fully meet ADA requirements, creating significant accessibility challenges for individuals with disabilities. Existing crosswalks are spaced far apart, which may encourage unsafe mid-block crossings. Absence of continuous sidewalks significantly reduces safety for non-motorized users.

Poor sidewalk pavement quality

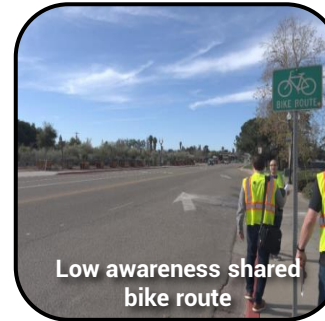
The evaluated street sections lack sufficient infrastructure to ensure safe movement of cyclists. Additionally, the absence of dedicated bike lanes significantly reduces safety for non-motorized users. The infrastructure that is in place is often in poor condition, with sidewalks and bike lanes that are worn down, abruptly ending, or inadequately maintained.

Low awareness shared bike route

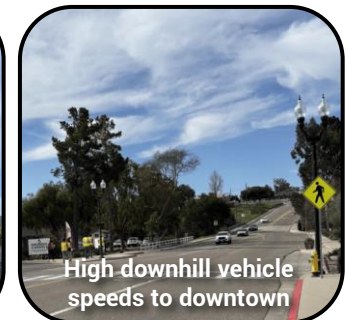
High downhill vehicle speeds to downtown

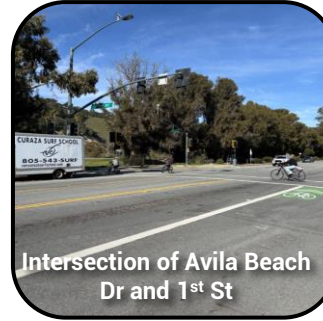
Intersection of Avila Beach Dr and 1st St

Near the intersection of 1st Street and Avila Beach Drive, high vehicle speeds, confusing traffic signals, and inadequate crossing times contribute to pedestrian risk factors. Tire marks on curbs indicate frequent vehicle contact, suggesting hazardous turning behavior. The lack of clear signage and signal coordination with bicycle phases can mislead pedestrians, creating unsafe crossing conditions. The unsignalized stretch from Harford Pier features narrow walkways and no dedicated pedestrian space, forcing all modes to share the vehicle lanes.

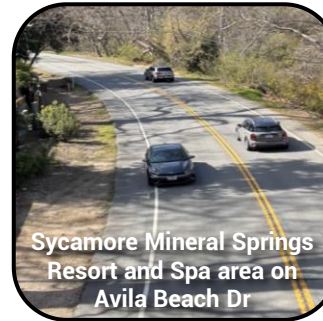
Sycamore Mineral Springs Resort and Spa area on Avila Beach Dr

Along Avila Beach Drive, high vehicle speeds, narrow shoulders used as bike lanes, and sharp curves with limited sight distance increase the likelihood of vehicle encroachment into areas used by cyclists. Foliage further obscures visibility. Near Sycamore Mineral Springs Resort, staff advise against cycling on the road due to safety concerns, instead recommending use of the Bob Jones Trail. Additionally, inadequate signage and wayfinding limit safe navigation for cyclists. At the intersection of San Luis Bay Drive and Avila Beach Drive, traffic signals do not detect bicycles, often forcing riders to wait for cars or run red lights, increasing exposure to traffic conflicts.

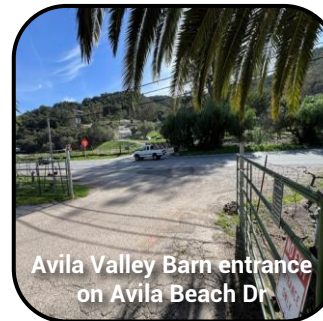
Avila Valley Barn entrance on Avila Beach Dr

Avila Beach Drive experiences excessive speeding during off-peak hours and severe congestion during peak times, creating unpredictable and often hazardous driving conditions. Sharp curves limit sight distance, increasing the risk of collisions, especially when visibility is impaired or during high-speed travel. Congestion can lead to driver frustration and risky maneuvers, and during holidays or festivals, impaired driving further heightens collision risk. The Level of Service "F" during peak periods indicates severe traffic breakdowns. At the entrance to Avila Valley Barn, faded markings, crumbling shoulders, and loose gravel create additional hazards, especially for turning vehicles, which may be rear-ended or delay following traffic.

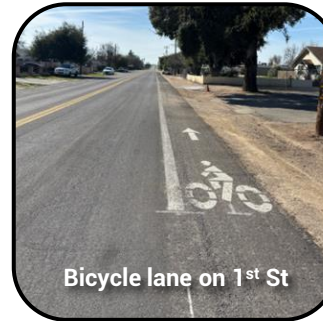
Bicycle lane on 1st St

Shandon lacks dedicated bicycle infrastructure making it unsafe for cyclists to navigate the area. Only one bicycle lane exists in Shandon, located on 1st Street in front of Shandon high school. Biking activity is low, evidenced by no cyclists being observed during the walk audit but further analysis may be required to see if there is any latent demand for bicycling suppressed by lacking infrastructure.

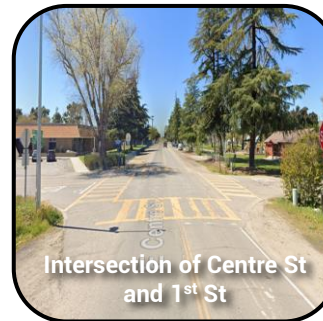
Intersection of Centre St and 1st St

There is limited visibility at intersections, frequent speeding, and inadequate enforcement of speed limits, especially with high volumes of pass-through and seasonal traffic. The lack of signage warning drivers to slow down contributes to unsafe driving behavior, and large trucks and farm equipment add to the complexity and danger on local roads. Wildlife crossings, such as wild pigs on Centre Street, present additional crash risks. Community concerns highlight the need for improved traffic calming, better enforcement, and infrastructure upgrades to enhance safety for all road users.

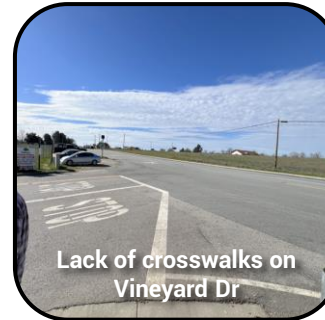
Near the Trader Joe's center, Vineyard Drive lacks crosswalks and sidewalk connectivity, leading pedestrians to cross travel lanes unsafely. Rossi Road, a high pedestrian area, has only one sidewalk and no marked crossings, causing confusion and unsafe behavior. Crocker Street is preferred for school travel due to slower traffic but lacks sidewalks. On Main Street, crosswalks are poorly lit and lack proper signage, with missing or misplaced pedestrian signs at key intersections like 4th and 6th Streets.

Lack of crosswalks on Vineyard Dr

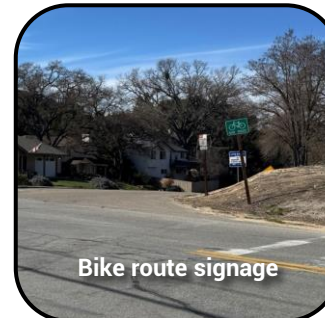
Bike route signage

Class II bike lanes on major roads lack buffers and protection from heavy traffic, creating discomfort and safety concerns. The community discourages biking over the overpass due to danger, especially for students. Rossi Road and Old County Road lack bike infrastructure, sidewalks, crosswalks, and lighting. While Crocker Street offers a Class III route, awareness is low, and it ends near a school loading zone. Eddy Street has no bike lanes or sidewalks, forcing users into traffic lanes and across a poorly lit bridge, increasing crash risk.

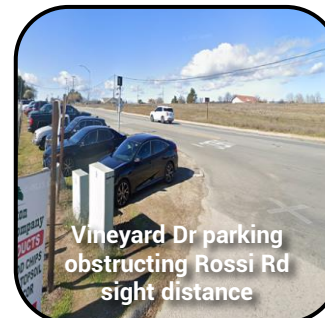
Trucks frequently use Rossi Road for deliveries, often parking in the center turn lane and obstructing visibility. Sight distance issues at the Vineyard Dr./Rossi Rd. intersection force drivers to pull past stop lines, increasing crash risk. Speeding is common on both Rossi Road and Old County Road, which lacks traffic calming features. On Old County Rd., wide lanes, poor sightlines due to vegetation, and uncontrolled intersections like 4th Street raise safety concerns. Eddy Street also sees frequent speeding and unsafe turning movements due to steep slopes, high-speed entries, and wide turn radii. Lighting is insufficient throughout, further increasing risks.

Vineyard Dr parking obstructing Rossi Rd sight distance

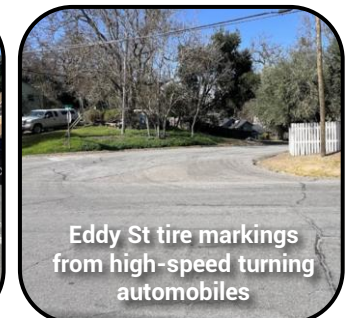
Eddy St tire markings from high-speed turning automobiles

A separate pedestrian bridge is recommended alongside the existing bridge on Eddy Street, similar to the pedestrian bridge on Florence Street. To reduce vehicle speeds on Eddy Street, it is recommended to install speed humps, crosswalk curb extensions, a roadway median, and a reduction of lane width leading to the bridge. Installing lighting, rumble strips, and speed limit signs would further increase driver awareness of the bridge conditions.

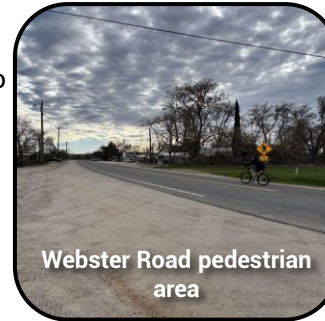
Webster Road pedestrian area

Speeding is common on Webster Road, with vehicles reportedly reaching up to 80 mph, often by unaware non-local drivers. Lack of pedestrian warning signs contributes to unsafe conditions near the school and shops. Drunk driving is a concern near the Longbranch Saloon at the "Budweiser Corner" intersection, a known hotspot for alcohol-related crashes. Long stretches without stop signs on Creston Road lead to unexpected stops at Highway 41, where limited sight distance and high-speed traffic increase the risk of collisions.

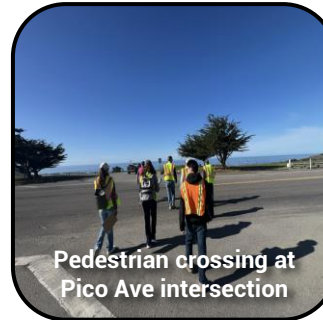
Pedestrian crossing at
Pico Ave intersection

No crosswalk is offered although beach parking often occurs across Highway 1 on Castillo Drive on busier days. This lack of connection causes unsafe pedestrian crossings to occur due to pedestrians having a hard time judging safe crossing gaps. There is no wayfinding sign guiding pedestrians to a safe crossing. Community members desire lighting so that drivers can see when people cross Pico Avenue over Highway 1. The community wishes these lights to be dark sky compliant due to star gazing activities along the scenic route.

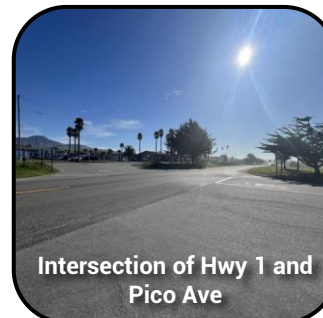
Intersection of Hwy 1 and
Pico Ave

San Simeon's coastal location causes frequent foggy conditions and poor visibility. Distracted and drowsy driving occur along Highway 1 as drivers are often focused on the scenery and features around the roadway. Some drivers may travel slower for sightseeing, causing other automobiles to pass them across a double yellow marking or through the bicycle lane. There is no gateway signage entering this community leaving many drivers unaware of the town's presence along the roadway.

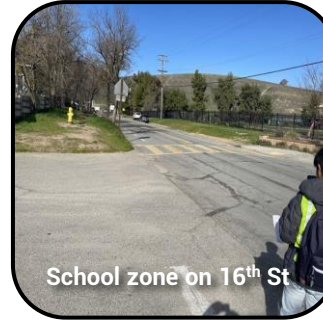
School zone on 16th St

There are missing sidewalks, unmarked crosswalks, and poor lighting on River Road/14th Street. Mission Street, the town's main thoroughfare, lacks continuous pedestrian infrastructure, with long crossings and abrupt sidewalk terminations forcing pedestrians into vehicle lanes. On 16th Street, near Lillian Larsen Elementary School, high vehicle speeds, wide curb radii, and missing sidewalks create unsafe conditions. L Street, a common student route, offers no pedestrian facilities, despite daily use by children walking to school.

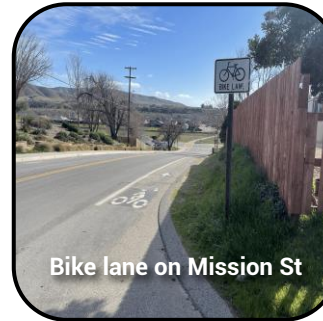
Bike lane on Mission St

A low-awareness (due to unmarked sharrow) Class III bicycle route is present along River Road/14th street. Only one, one-way unbuffered bicycle lane is offered on Mission Street, traveling northbound. Bicyclists traveling southbound experience confusing paths. The audit team observed a young bicyclist riding in the wrong direction to reach a corner market. Separated bicycle lanes are provided on 16th Street; however, they are often inaccessible due to automobiles parked within these lanes. Bicyclists are therefore often required to enter the automobile lane to go around the parked automobiles.

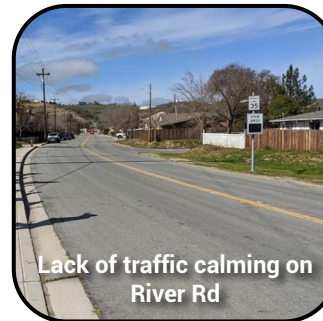
River Road connects the City of Paso Robles to San Miguel and locals use this road to reach Mission Market and the new residential development near Verde Place. High automobile speeds are frequently observed along this roadway, however, there is a speed feedback sign with 35 MPH speed limit. The roadway's wide cross section and lack of traffic calming, even inciting informal 'racing' events that have become popular in this area. Wide curb radii were identified at the intersection with N Street. On Mission Street ADA ramps are missing in several crosswalk locations. L Street is wide, straight and has no traffic calming features, resulting in speeding automobiles. Wide curb radii encourage dangerous high-speed turns.

Lack of traffic calming on River Rd

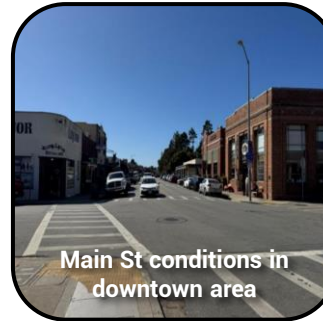
Main St conditions in downtown area

The walk audit team identified long crossing distances and crowded sidewalks along this area of Main Street. Pedestrians were observed dashing across the street. Further south, Main Street and Santa Rosa Creek intersection provides a connection to Coast Union High School and a smaller Leffingwell High School. Limited sidewalk or other active travel infrastructure is present in this area. Crosswalks along Main Street is unmarked, and no school zone signage is present. Westbound sight distance near this crosswalk is also limited due to the horizontal curve that connects to the bridge on the creek. Students from the high schools located on the Santa Rosa Creek Road are often observed crossing this unmarked crosswalk.

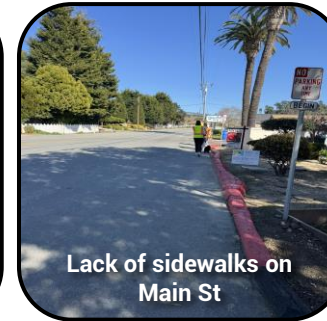
Lack of sidewalks on Main St

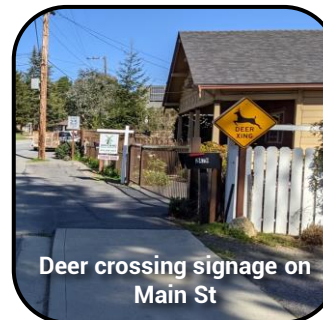
Deer crossing signage on Main St

Automobile drivers ignore stop signs and speed limits. Distracted driving is common especially for tourist drivers sightseeing or searching for a convenient parking space. Auditors observed a near-miss collision between two automobiles on the roadway. Traffic calming is minimal in this area, which means speeding is also an issue for wildlife-related (primarily deer) collisions in the area. Even though the team visited the location on a bright day, Cambria residents shared that lighting is poor within this area.

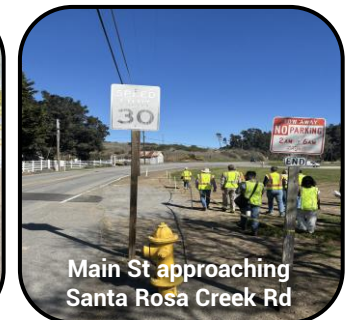
Curved road on Main St limiting sight distance

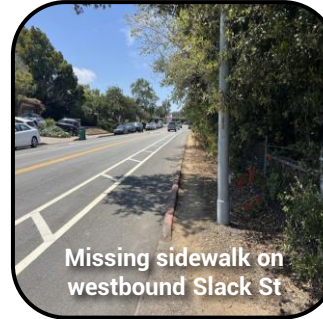
The area includes missing or narrow sidewalks, lack of marked crosswalks, and poor accessibility for individuals using wheelchairs or strollers. On Slack Street, westbound pedestrians must walk on a narrow dirt path or in the bike lane due to the absence of sidewalks, while the eastbound sidewalk is narrow and discontinuous. Frequent jaywalking occurs because of long stretches without midblock crosswalks. At the school loading zone, existing crosswalks lack painted markings. On Grand Avenue, sidewalks are present in both directions but are often incomplete, missing curb cuts, and become narrow in certain areas, limiting safe and accessible pedestrian travel.

Missing sidewalk on westbound Slack St

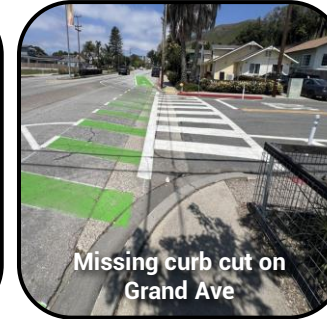
Missing curb cut on Grand Ave

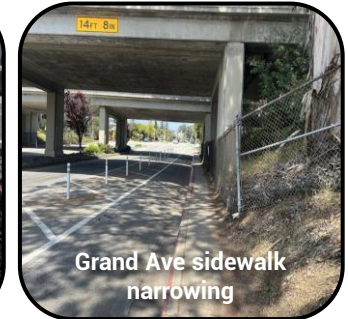
Grand Ave sidewalk narrowing

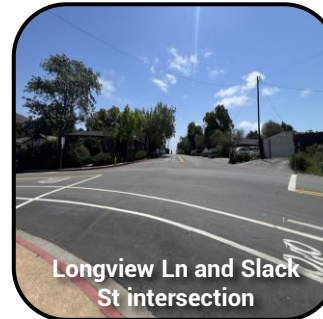
Longview Ln and Slack St intersection

The area includes the absence of dedicated bike lanes on key routes such as northbound Longview Lane and conflicts with other users at shared intersections. Students using scooters and skateboards often pass through the Slack Street and Longview Lane intersection, creating conflict points due to lack of infrastructure. Driver behavior remains a concern, with vehicles making high-speed turns from side streets and ignoring turn restrictions, which poses ongoing hazards to bicyclists.

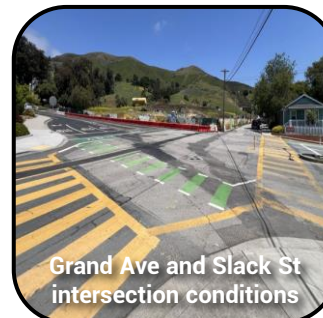
There is significant congestion and overflow traffic at the Longview Lane and Slack Street intersection due to nearby residential neighborhoods, two schools, and the main Cal Poly campus entrance. The unusual intersection geometry, including a driveway feeding directly into it, adds complexity and conflict potential. Grand Avenue experiences high volumes and speeding, particularly during off-peak times. At the Slack Street and Grand Avenue intersection, multiple approach lanes and limited visibility can prevent drivers from seeing crossing pedestrians. At the Grand Avenue and McCollum Street intersection, obstructed sight lines force turning vehicles into crosswalks to gain visibility, increasing collision risk.

Grand Ave and Slack St intersection conditions

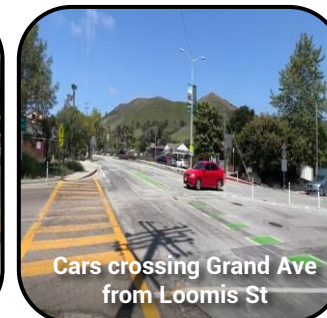
Cars crossing Grand Ave from Loomis St

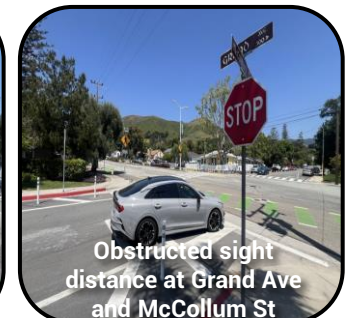
Obstructed sight distance at Grand Ave and McCollum St
