Walk Audit Report

2025 SLO REGION

Nipomo Field Walk – February 21, 2025

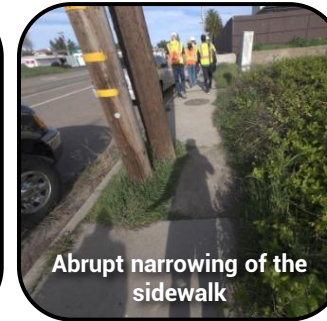
Abrupt narrowing of the sidewalk

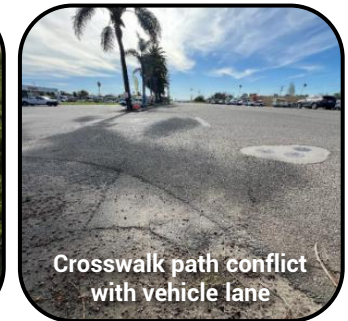
Crosswalk path conflict with vehicle lane

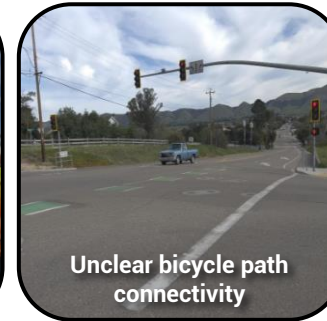
Unclear bicycle path connectivity

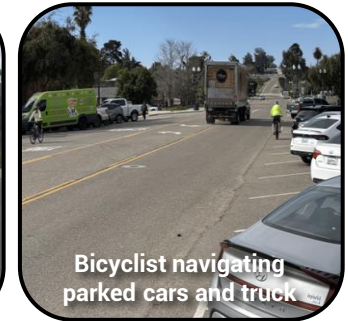
Bicyclist navigating parked cars and truck

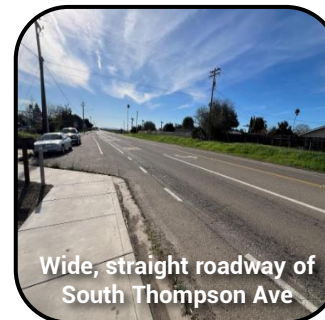
Despite relatively low posted speed limits, vehicles frequently travel at excessive speeds along South Thompson Avenue due to roadway design. The primary geometric contributor to these high speeds is the wide roadway section. Additionally, the grade near US101 on- and off-ramps to West Tefft St. facilitates acceleration, further increasing speed concerns. The straight alignment of South Thompson Avenue leading to and from Highway 101 also contributes to increased vehicle speeds, posing safety risks for pedestrians and cyclists.

Wide, straight roadway of South Thompson Ave

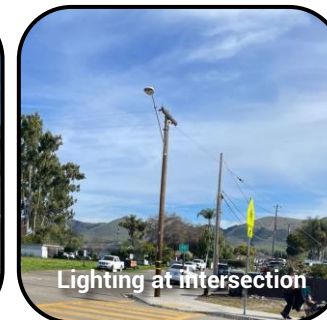
Lighting at intersection

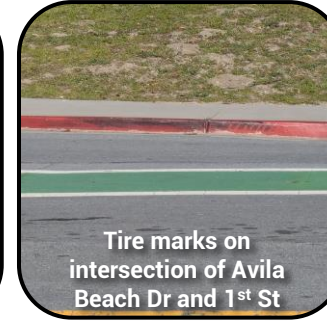
Near the intersection of 1st Street and Avila Beach Drive, high vehicle speeds, confusing traffic signals, and inadequate crossing times contribute to pedestrian risk factors. Tire marks on curbs indicate frequent vehicle contact, suggesting hazardous turning behavior. The lack of clear signage and signal coordination with bicycle phases can mislead pedestrians, creating unsafe crossing conditions. The unsignalized stretch from Harford Pier features narrow walkways and no dedicated pedestrian space, forcing all modes to share the vehicle lanes.

Tire marks on intersection of Avila Beach Dr and 1st St

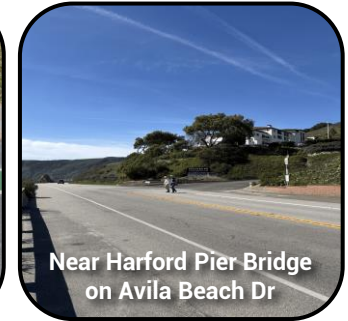
Near Harford Pier Bridge on Avila Beach Dr

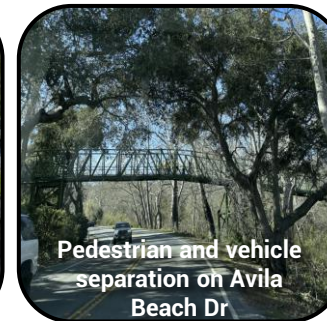
Pedestrian and vehicle separation on Avila Beach Dr

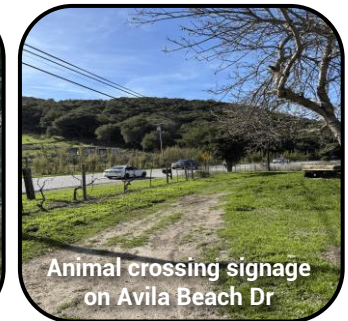
Animal crossing signage on Avila Beach Dr

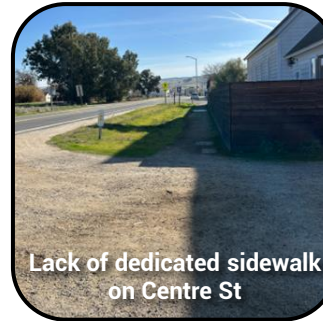
There are a lack of sidewalks, marked crossings, and accessible infrastructure, forcing people to walk on narrow shoulders or unpaved surfaces. High vehicle speeds, especially on Centre Street during peak seasons, limited midblock crossings, and poor lighting further increase danger for non-motorized users. The area lacks curb ramps, wayfinding signage, and safe routes to schools, particularly affecting students, individuals with disabilities, and the elderly. Community members also raised concerns about drainage issues and safety near the high school's pick-up and drop-off area.

Lack of dedicated sidewalk on Centre St

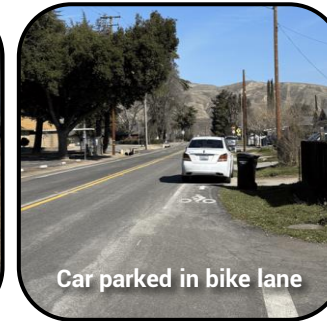
Car parked in bike lane

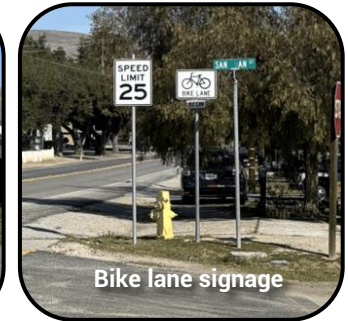
Bike lane signage

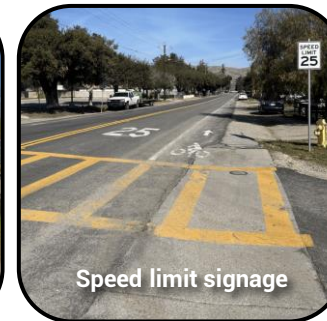
Speed limit signage

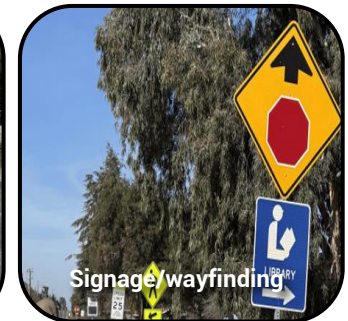
Signage/wayfinding

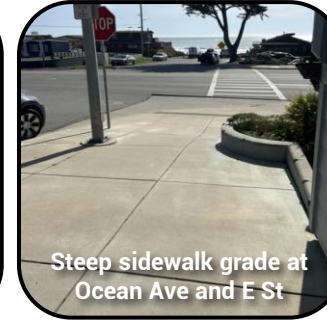
Steep sidewalk grade at
Ocean Ave and E St

Installing a handrail at the steep sidewalk on E street (and other streets heading east from Ocean Ave) would reduce the pedestrian difficulty of navigating this section. Pedestrians with limited mobility can use the handrail as a support to reduce tripping hazards.

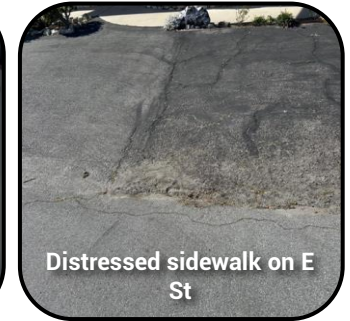
Distressed sidewalk on E
St

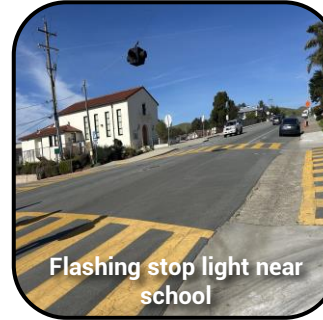
Flashing stop light near
school

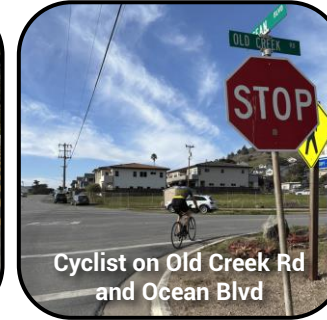
Cyclist on Old Creek Rd
and Ocean Blvd

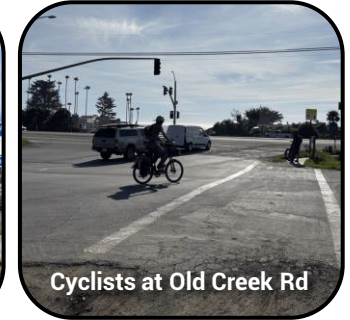
Cyclists at Old Creek Rd

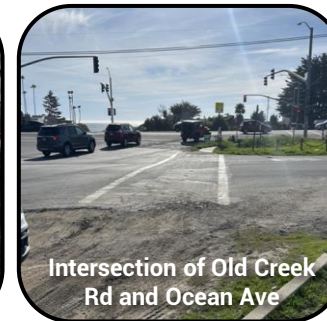
Intersection of Old Creek
Rd and Ocean Ave

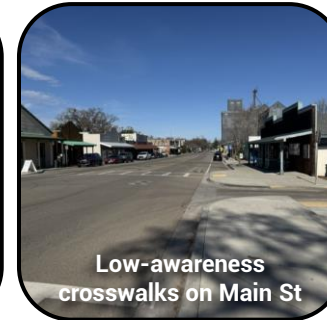
Low-awareness crosswalks on Main St

It is recommended to install RRFBs, curb extensions, and pedestrian refuge islands at the Main Street intersections on 4th Street and 6th Street, since these intersections experience the highest pedestrian volumes. Installing a raised roadway median will address the identified automobile speeding risk factor. The parking lane is recommended as a buffer for bicyclists, protecting them from heavy vehicles.

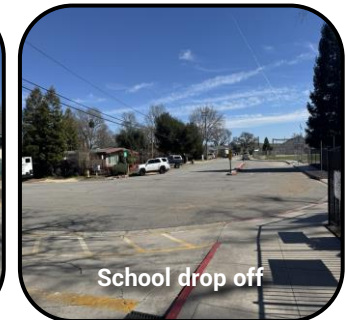
School drop off

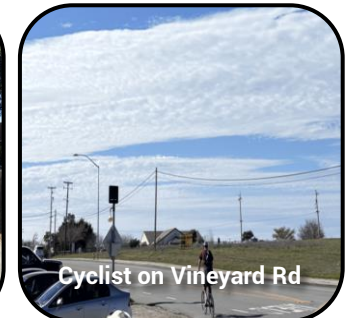
Cyclist on Vineyard Rd

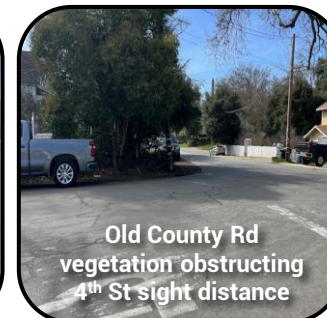
Old County Rd vegetation obstructing 4th St sight distance

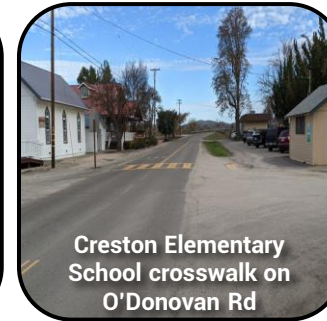
Creston Elementary School crosswalk on O'Donovan Rd

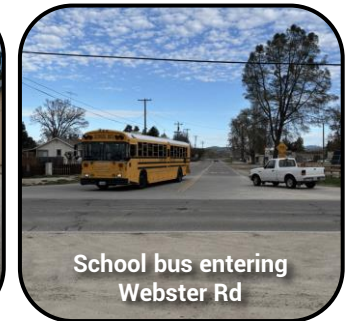
School bus entering Webster Rd

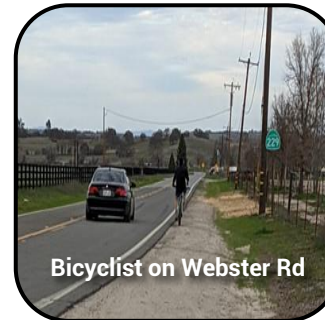
There is no bike lane or shoulder to create separation from the high-speed traffic. One bicyclist was observed during the walk audit riding along speeding automobiles. O'Donovan Road functions as a heavy vehicle route and presents concerns for bicyclists using the Class III shared route on this roadway.

Bicyclist on Webster Rd

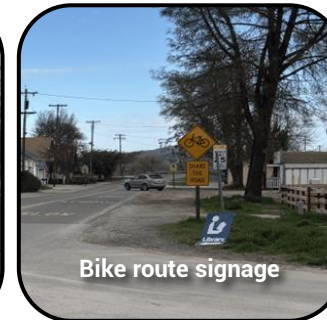
Bike route signage

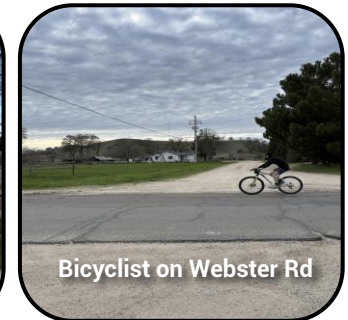
Bicyclist on Webster Rd

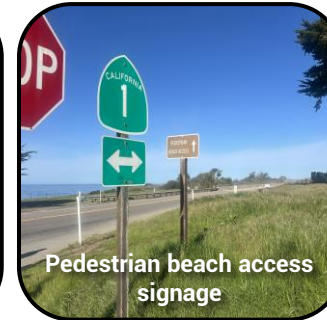
Pedestrian beach access
signage

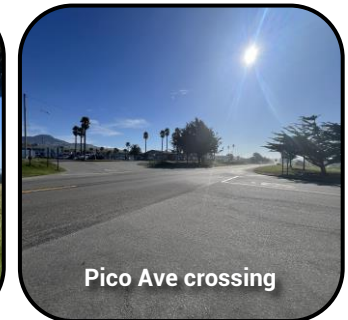
Pico Ave crossing

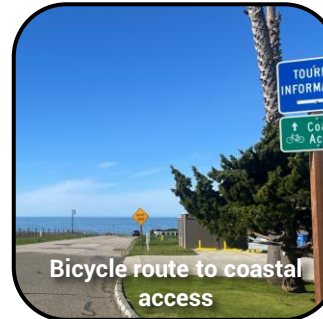
Bicycle route to coastal
access

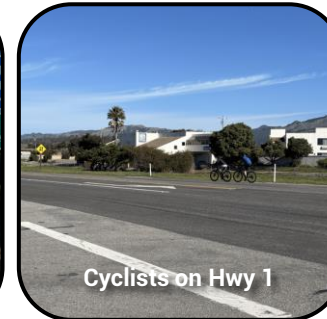
Cyclists on Hwy 1

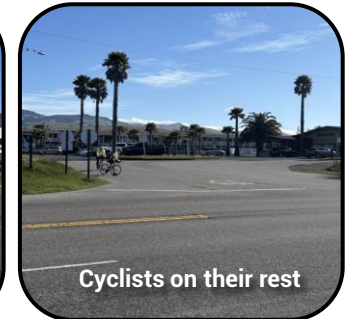
Cyclists on their rest

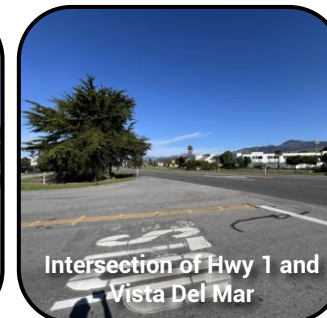
Intersection of Hwy 1 and
Vista Del Mar

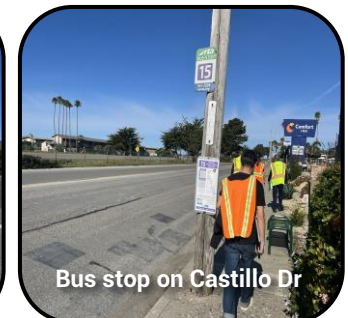
Bus stop on Castillo Dr

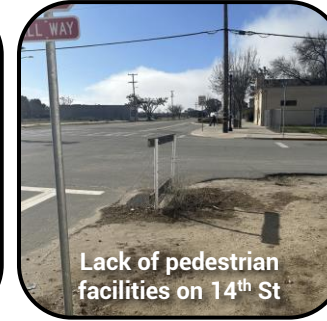
Lack of pedestrian facilities on 14th St

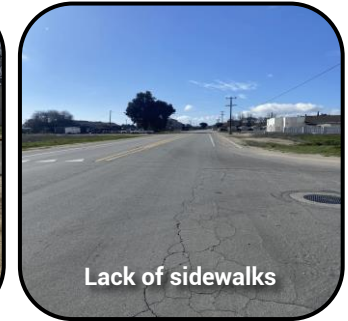
Lack of sidewalks

Mission Street experiences higher demand for active travel modes yet offers limited supportive infrastructure. Sidewalks should be installed to add a pedestrian path connection between 16th Street and 14th Street. A Southbound bicycle lane should be added to provide cyclists with an accessible route in this direction. ADA ramps should be added at crosswalks where they are missing.

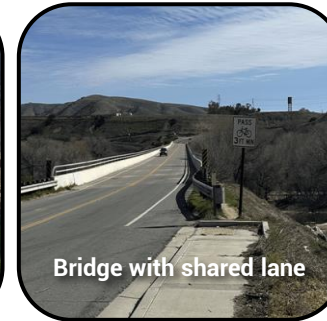
Bridge with shared lane

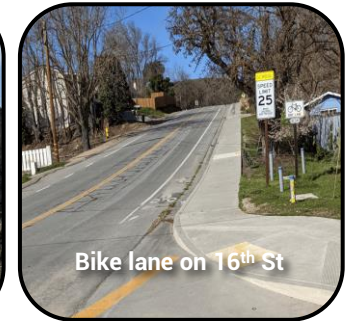
Bike lane on 16th St

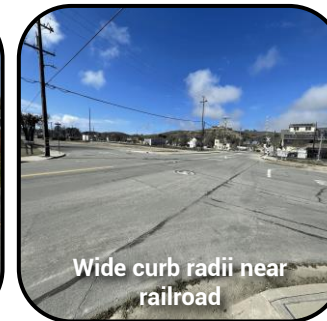
Wide curb radii near railroad

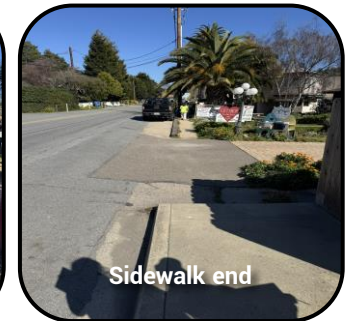
Sidewalk end

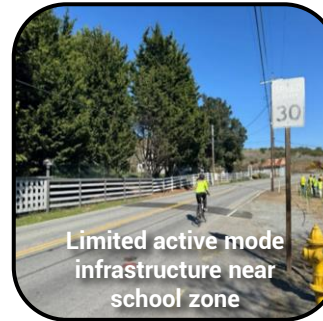
Limited active mode infrastructure near school zone

An RRFB is recommended to allow students a safe route crossing Main Street. In addition, the speed limit should be lowered to 25mph in the school zone. This reduction would also reduce the nearby deer-crossing hazard. High-visibility crosswalk path markings are recommended to be painted near the school zone. Sidewalks should be installed to connect this area to Downtown Cambria and eliminate pedestrian-automobile conflicts.

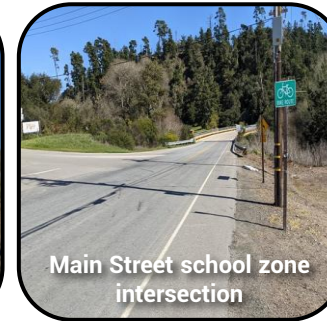
Main Street school zone intersection

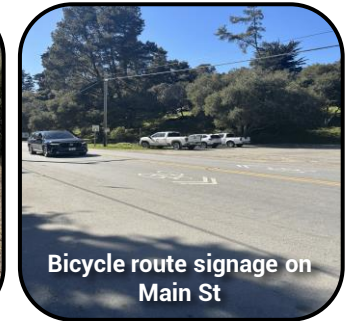
Bicycle route signage on Main St

It is recommended to replace the Class III bicycle route with separate bicycle lanes along the roadway. These bicycle lanes would be more practical for bicyclists as sharing the roadway with constant heavy-vehicle traffic decreases comfort levels. Bicycle lane connections should include high-visibility paint.

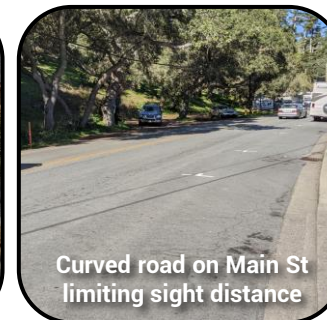
Curved road on Main St limiting sight distance

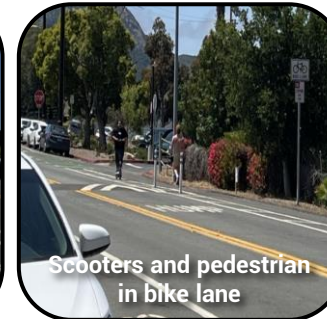
Scooters and pedestrian in bike lane

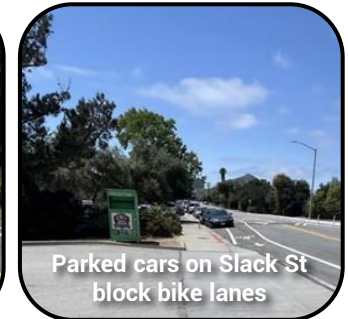
Parked cars on Slack St block bike lanes
